Air Force Research Laboratory AFRL

Success Story

AUTOMATED MOTION-COMPENSATION AND SEMI-AUTOMATED RESTORATION TECHNIQUES

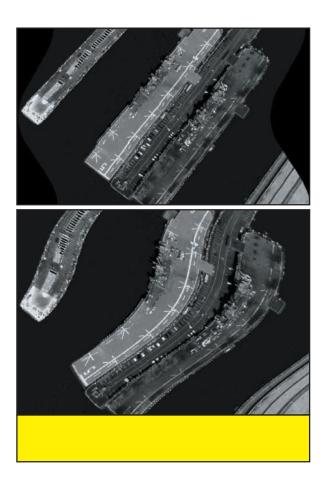
Images acquired from aircraft-mounted line-scan sensors are subject to distortions caused by changes in platform speed, direction, orientation, or altitude. Even with camera stabilizers, aircraft movements create distortions in line scans. These distortions can reduce the ability to identify characteristics of objects or make the objects completely unrecognizable. For example, when an aircraft begins scanning a building at one altitude, then climbs to a higher altitude before completing the scan, the width of the building appears to become progressively narrower over its length.

Directorate engineers achieved a compensated image for the EO imagery on highly distorted images by applying a matched filter to each line. For hyperspectral imagery, the directorate completed an optimally matched filter from selected frequency bands, then propagated it through the other frequencies. The engineers successfully demonstrated the line scanmatched filter even when camera stabilizers failed, when no geographic reference or available navigation data existed, and when sensor failure resulted in incomplete data.
